MICE Spectrometer Solenoid Repair

MICE Spectrometer Solenoids

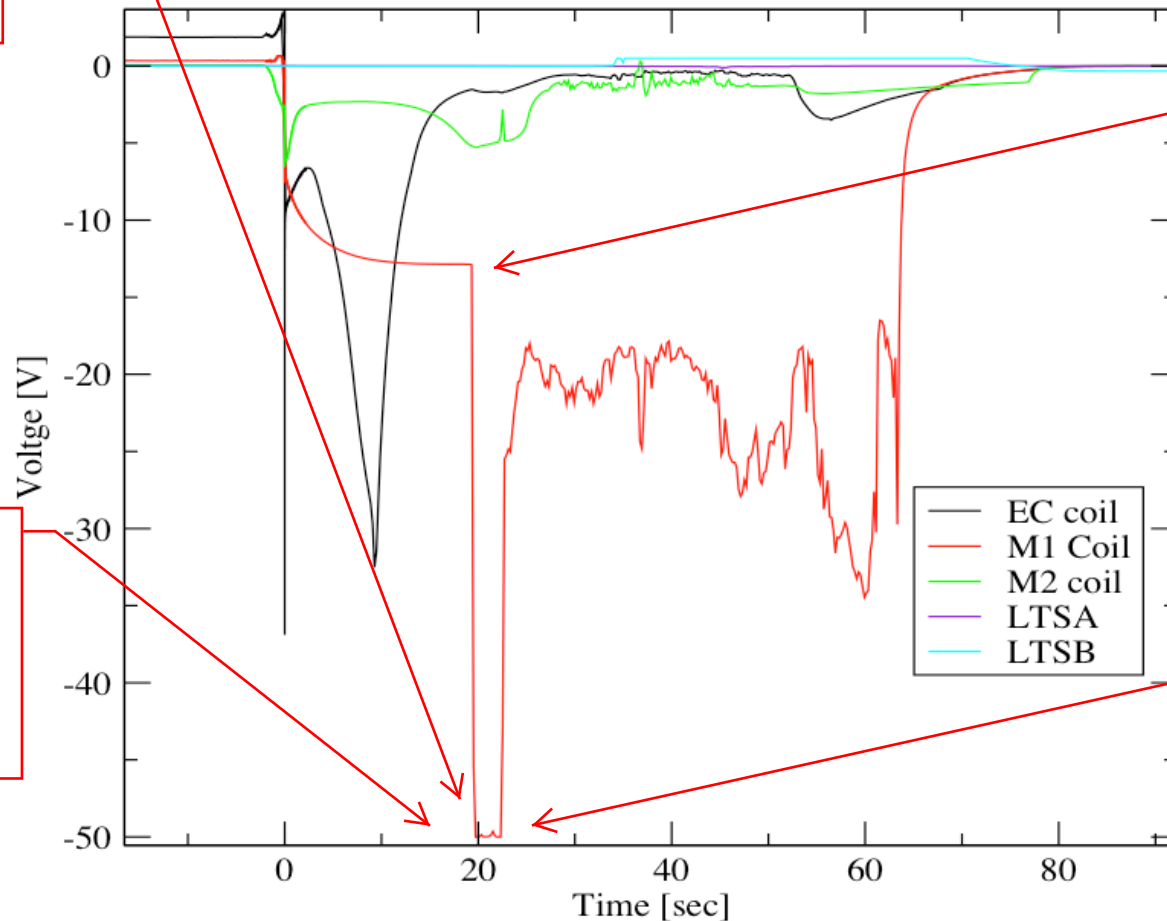
Quench on September 13th

I would guess the following: the diode lead burned out first (why) and then a high voltage on the leads caused the breakdown of the feed through area. Do we have evidence, pictures?

I have no where seen an explanation of the cause of the high voltage, not explained, or not known, or?

20 s point!

why 50V, real or saturated channel, if so, what is the real voltage? and why?

Pg. 10: Scenario: Quench originated in ECE, onsite of quench in M1 delayed due to M2 not being powered; at ~ 20 sec a connection in the diode/resistor pack for M1 failed (open created), with contactors open – no place for current to go – voltage builds rapidly. QP detection system saturates at 50V. Arcing begins. Most likely place is at the He side of the power feedthrough. Arcing continues until ~ 63 sec. No pictures. Have to open the magnet first.

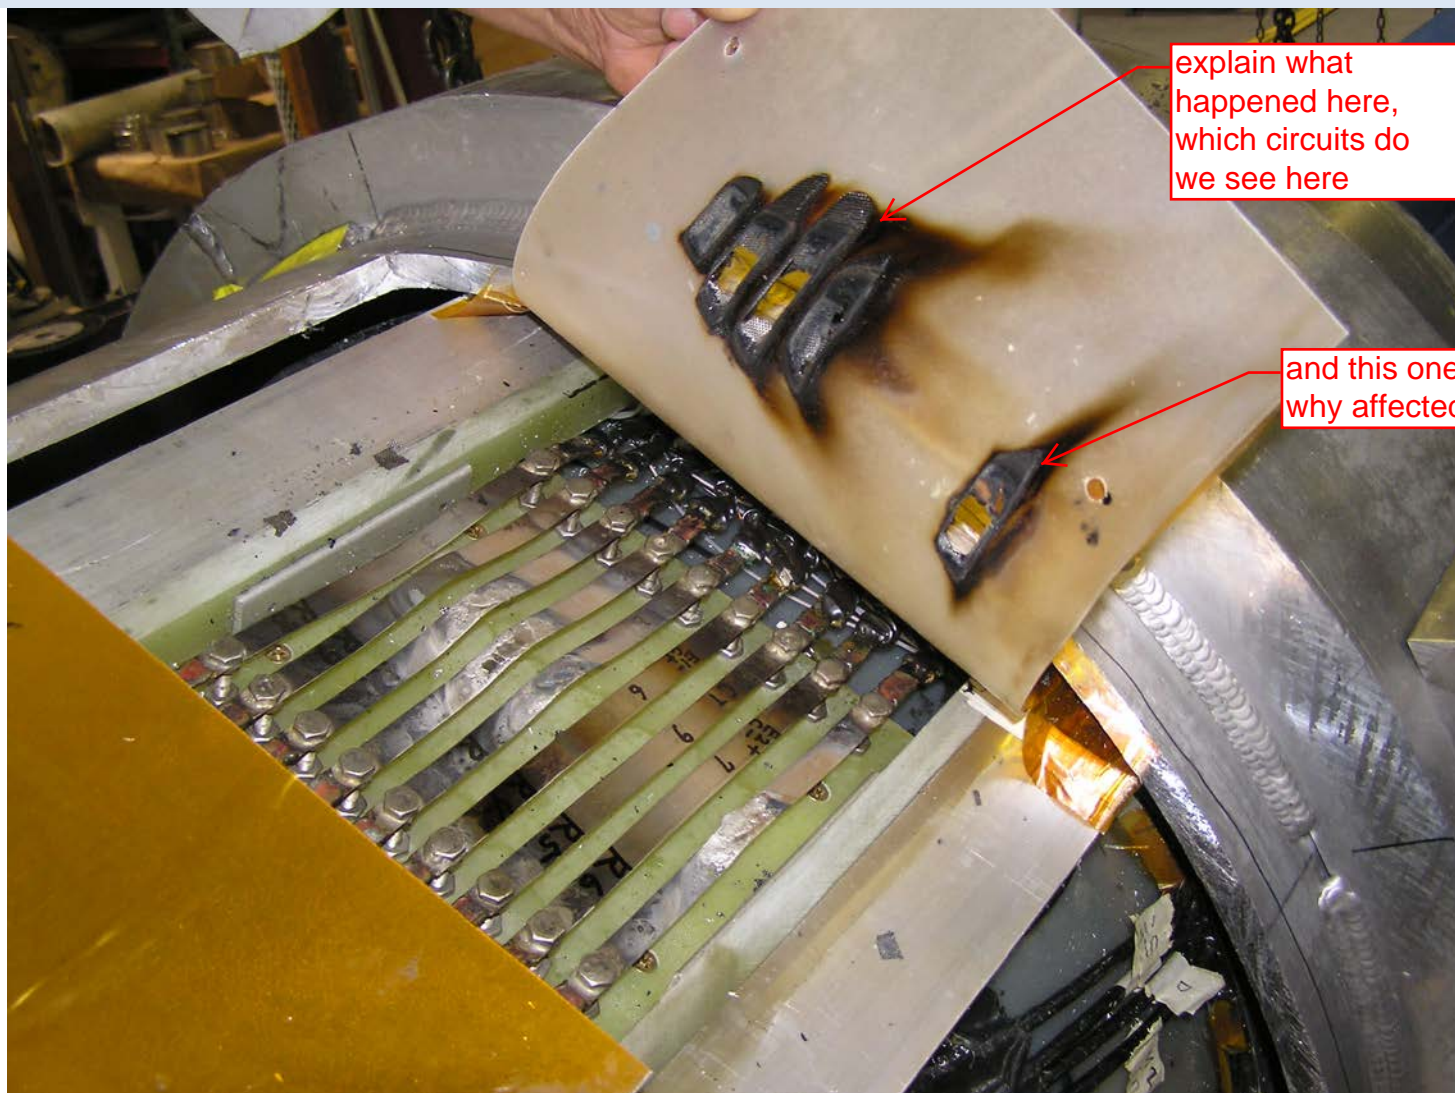
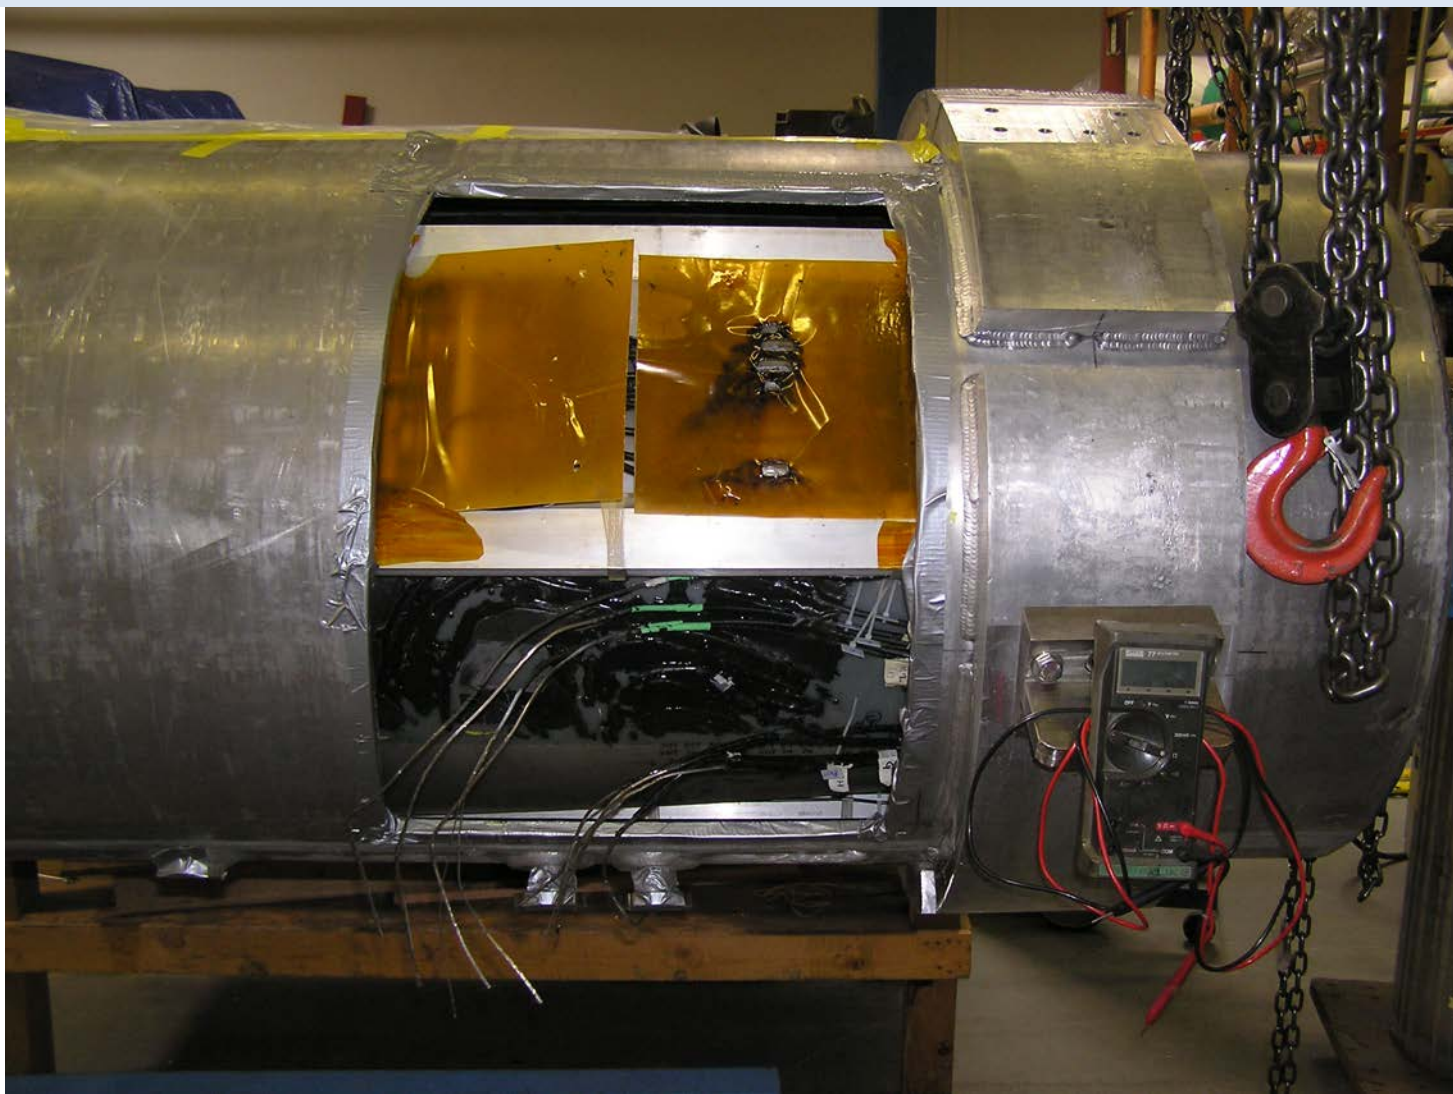
Original Wang configuration

What happens here with varying helium conditions? When in liquid it can hold high voltage, when in gas, much less. What is the angular position of this protection unit in operation?

why do we need these resistors?

are these in liquid or in gas, or it depends, if so, on what, and what were the circumstances when it failed?

gas environment here? pressure issues?

soldered only? but heating up yo high temperature, another mistake?

Pg. 13: See page 9 of the presentation. Failure as indicated. Most likely the connection between the diode stack and the resistor (see photo pg. 18 of presentation, lower left – as marked R7).

Pg. 14: Normal running conditions indicate a LHe level that is $\geq 95\%$ in the upper LHe level sensor. In this case, the QP pack (resistors and diodes) and feedthroughs are always in liquid. In the event of September 13th, the upper LHe level sensor was reading > 98%. QP system was submerged in LHe up to the time of the quench. Yes, soldered only in this case. In the case of SSU, however, the SC lead was attached to the resistor with multiple wraps of Cu wire. See picture on pg. 17.

Pg. 15: Upper 4 burns – M1+/M1-/M2+/M2-. Lower one is E2 (+ I believe).

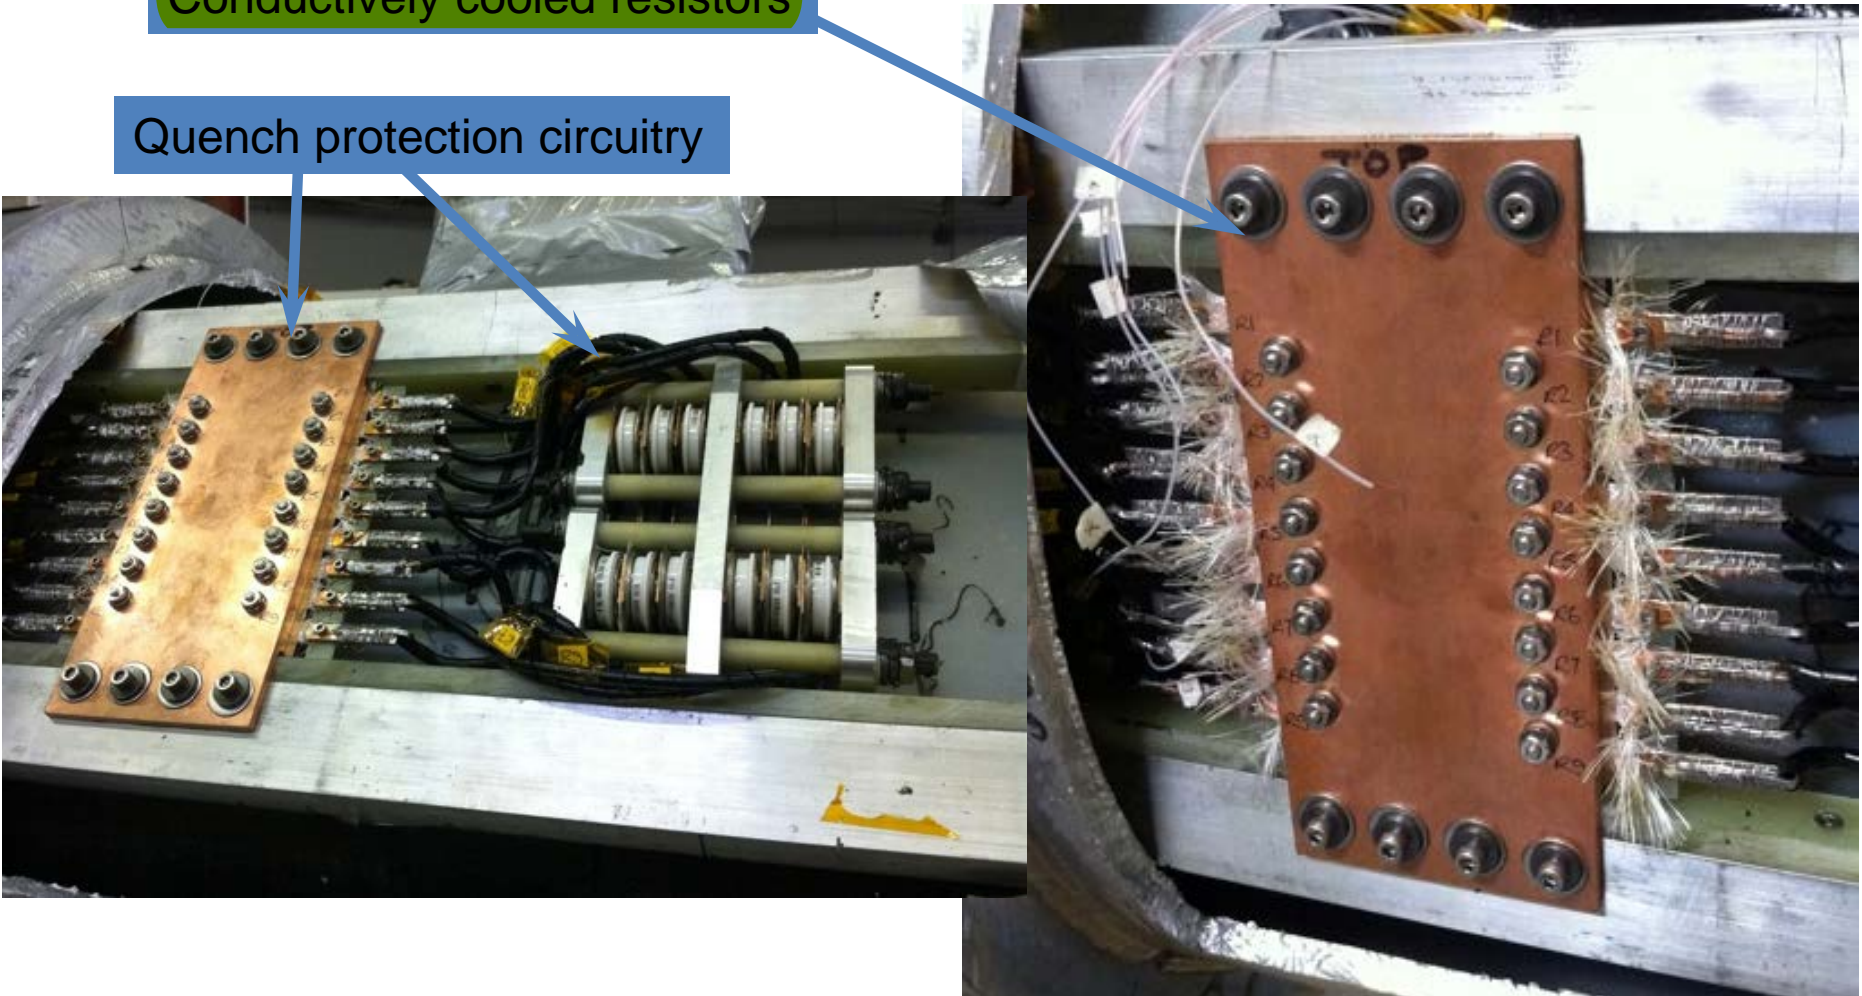
Picture of final configuration for SS2/SSU

Conductively cooled resistors

Quench protection circuitry

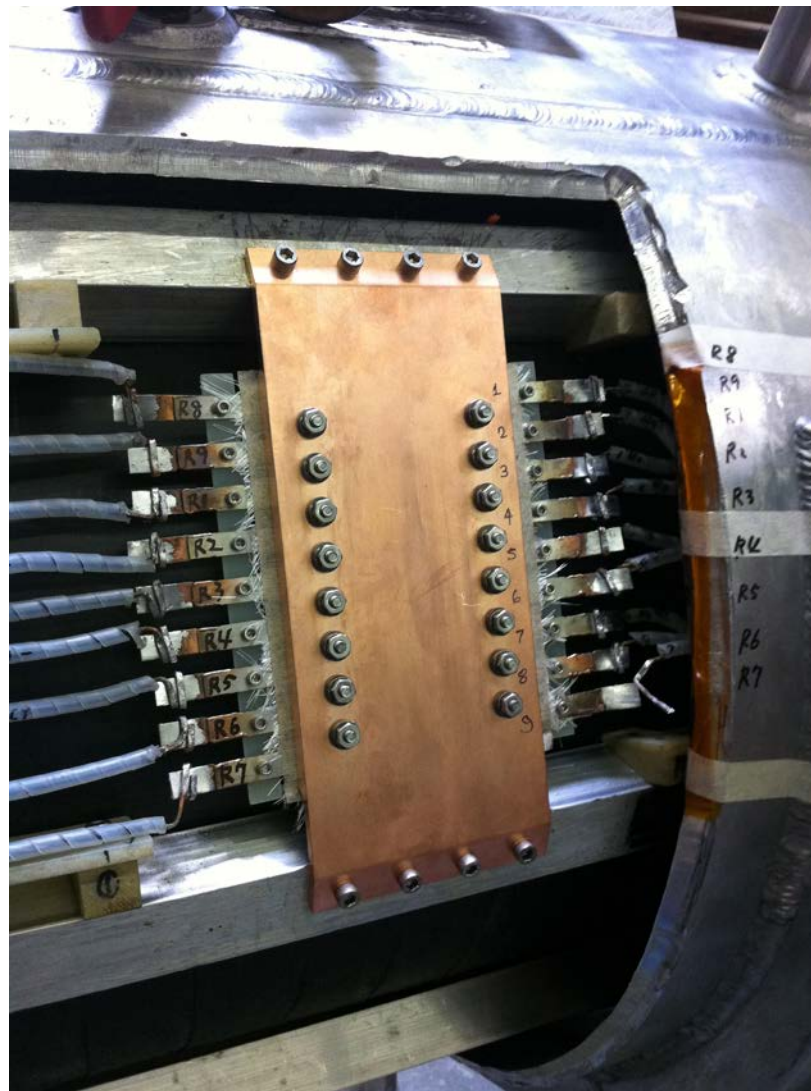
SS1/SSD

This is a photo of the QP pack for SSD/SS1. What is not known at this time is exactly how the terminations were made. Did Wang follow the procedures used on SSU/SS1?

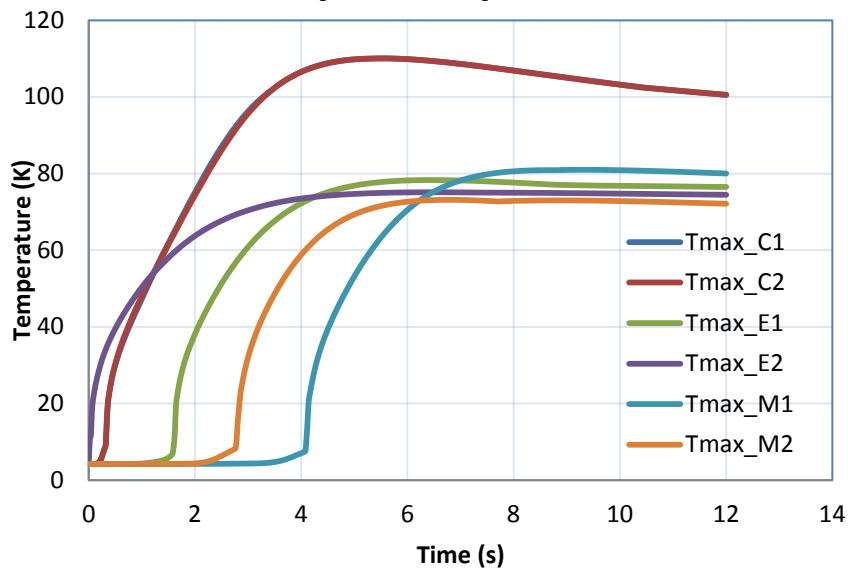
Case I
Hot Spot Temperature

- Compared the results with (case I) and without (case II) M2 powered.
- Quenches were initiated in E2 in both cases.
- The quench current in case I is 265A in all coils.
- In case II, the quench currents in ECE and M1 are 260A and 250A, respectively.
